X-ray Microtopography: *Mapping Deformation Fields in Integrated Circuit Metallization*

I. C. Noyan

Columbia University-SEAS-APAM
IBM Research Division

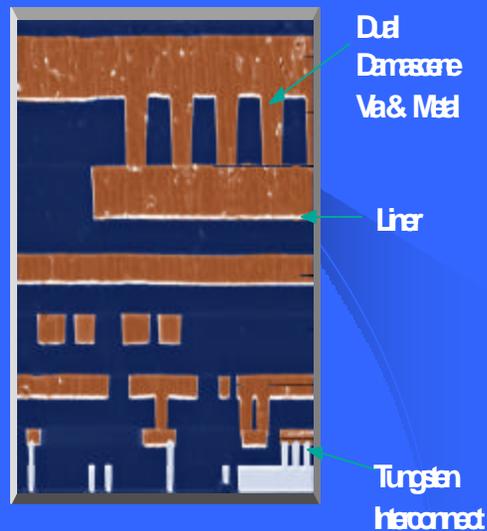
Each chip has millions of transistors, comparable number of passive elements,

Many meters of sub-micron interconnection wire on multiple levels,

Several million vias that connect these levels.

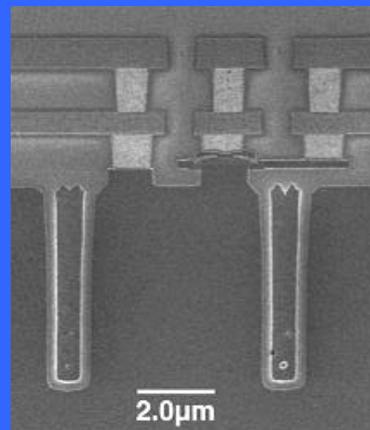
SEM cross-section of SiGe HBT showing deep and shallow trench isolation with two levels of planar metal interconnection .

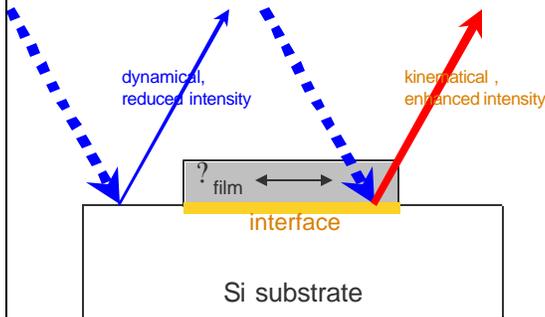
- ✍ Divergent beam..
- ✍ Patterns of metal (W, Ni, Cu, Al) dots.
- ✍ We map the intensity of a silicon reflection in the plane of the wafer.

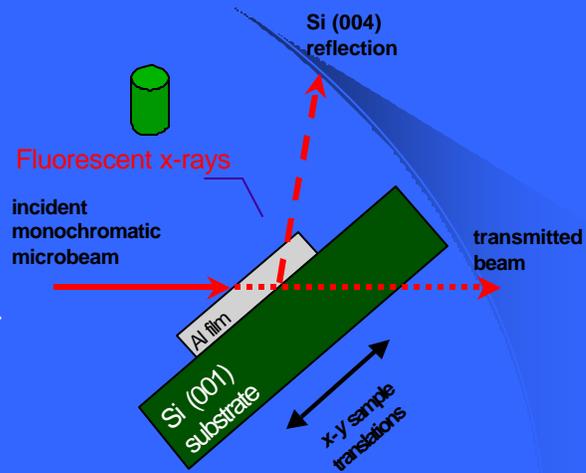
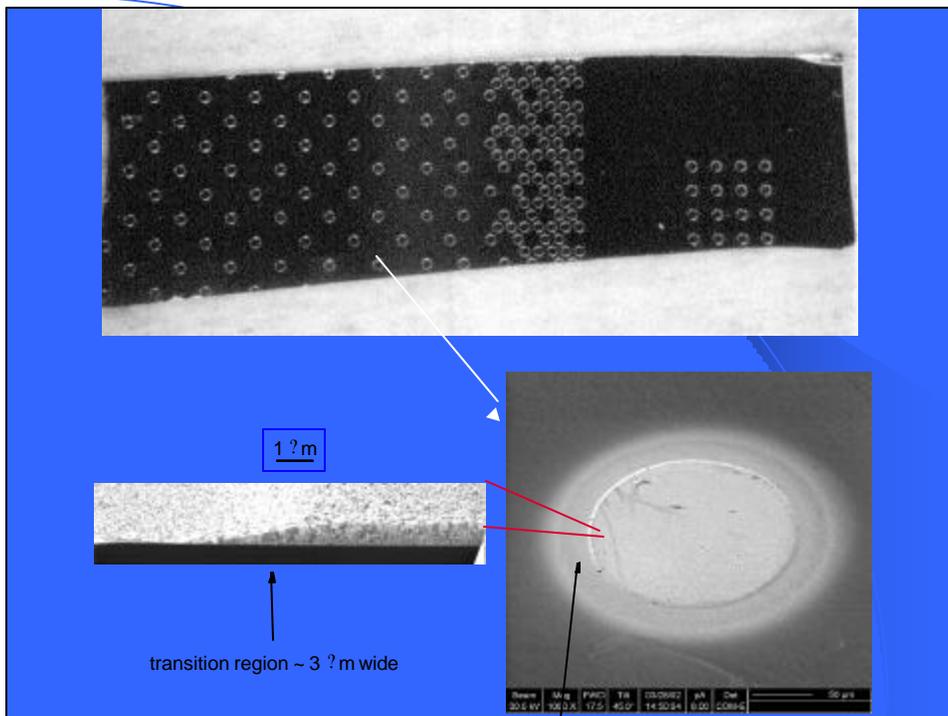
The Ni-K α map from a Ni sample with 170 micrometer radius dot array.

The dots are 1 micrometer thick, evaporated at ambient temperature on Si 111 type substrates.

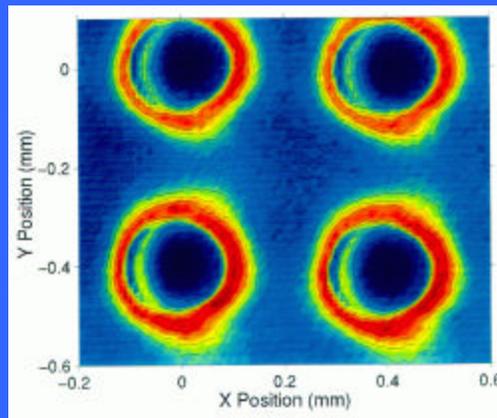
If we look at a cross-section through four dots, we observe:

- The shear maxima are at the edges. However, they are displaced out from the dot edge, which contradicts theory.
- Intensity is below the dynamical limit at the dot center.
- In regions between dots, the shear fields overlap.

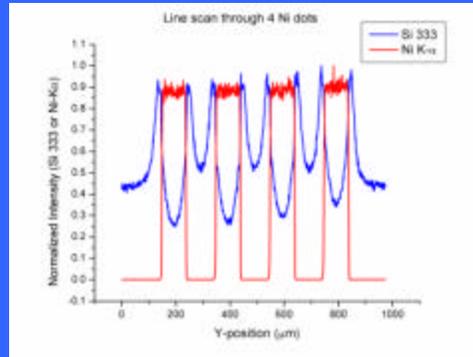
Enhanced Si (333) intensity

- Line scans of Si (333) vs. position confirm diffracted intensity increase due to strain
- Effects of Ni dot observed in Si substrate approximately 120 μ m away

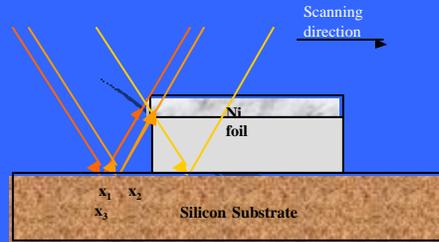
The previous slides contained raw data, which did not take into account the presence of absorption. This effect was analyzed and corrected.

$$I(x) = I_0 \int_0^h e^{-\mu(x)z} G(z) dz$$

$$G(z) = \frac{e^{-\mu(x)z/\sin(\theta)}}{\int_0^h e^{-\mu(x)z/\sin(\theta)} dz}$$

$$I(x, y) = \int \int G(z) e^{-\mu(x)z} B(x, y) dx_B dy_B dz$$

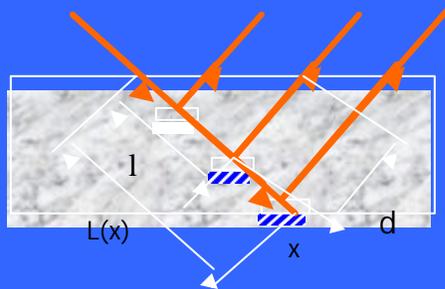
Fluorescence

We assume the excitation of fluorescence on each block is proportional to the intensity of incident x-ray on that block, which is equal to

$$KI_0 e^{-\mu l}$$

The excited fluorescence will be attenuated by a length d before it can emit from the surface, so the final expression is

$$I(x)_{Fluorescence} = KI_0 \int \int e^{-\mu l} B(x, y) dl dx_B dy_B$$

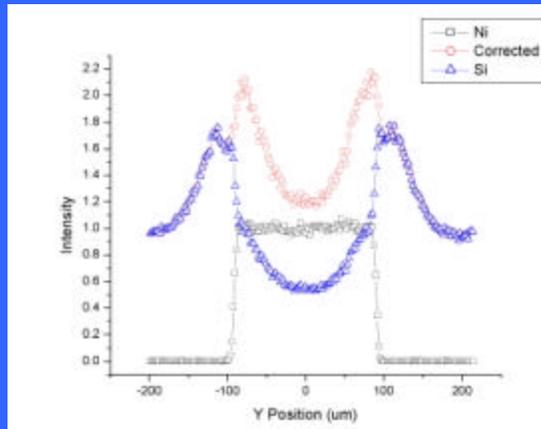
When the corrections are applied we obtain:

- The shear maxima are at the edge.
- There are two subsidiary maxima outside the edge.
- These are caused by a halo of Ni around the dot.

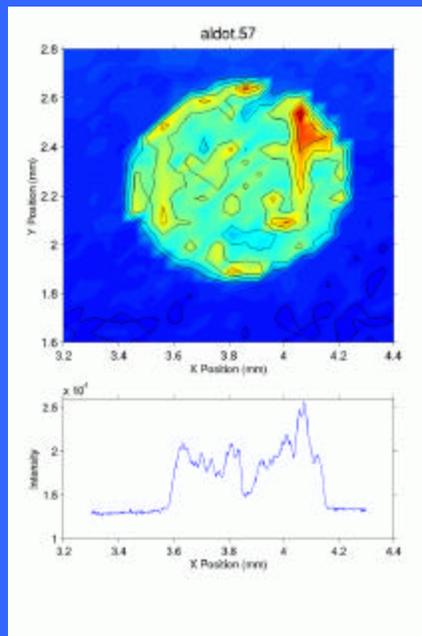
Microbeam topography can also be used to qualitatively identify interfaces.

Multiple shear maxima inside the dot indicate an “interrupted” interface.

The average distance between the shear maxima describes the “critical adhesion length” of the interface.

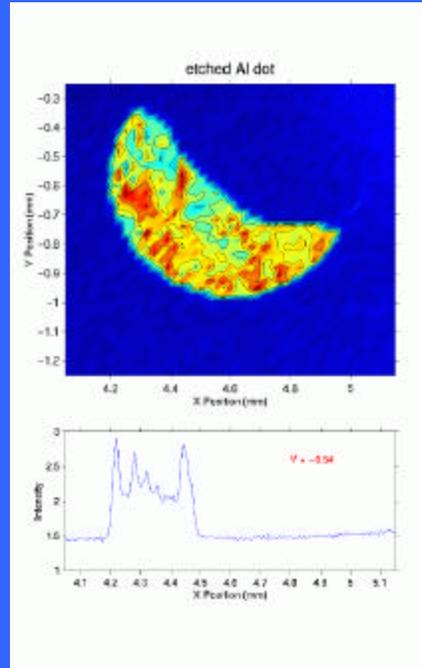
The shear effects are purely elastic.

If the dot is etched, there is no remaining shear contrast in the case of Al.

In the case of the Ni dots, the issue is more complicated.

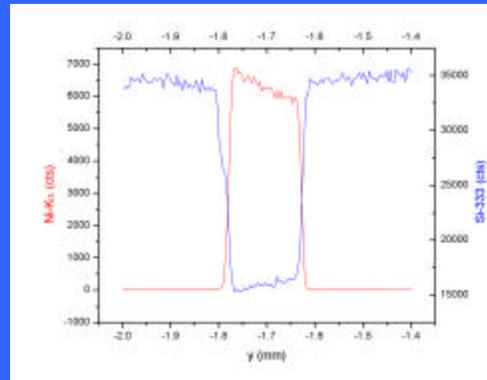
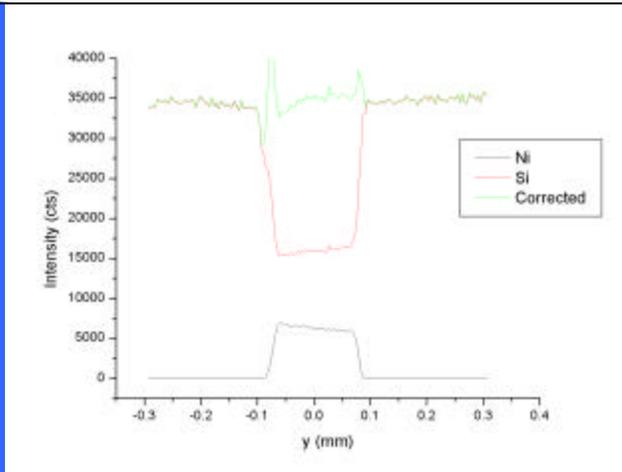
If we etch the Ni dots, and map a dot that is still left on the surface, we see that most of the shear-peaks are removed.

If we correct the intensity for absorption, we see that there is still some adhesion.

The edges still retain some degree of shear.

Full reciprocal-space mapping of the (un-etched) Ni dots revealed a “coherent” second layer near the edge.

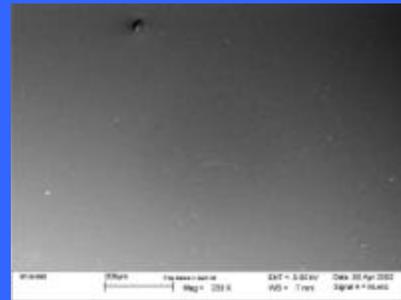
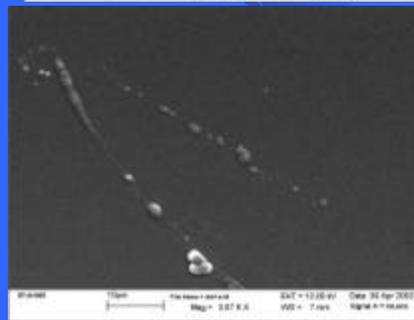
The decorations may be silicides, they show faceted topology.
 The native oxide also appears to be damaged.
 This may be due to the high stress in the Ni films.
 Measurement of the Ni stress using macro-beam techniques yielded an in-plane stress around 1 Gpa.
 There will be a comparable shear stress at the edges.
 This issue is under further study.

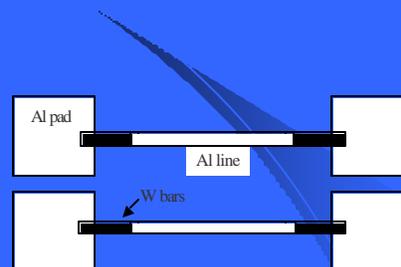
At such current densities the electron flow biases atomic diffusion.

The atoms move downwind with the electron "wind", from cathode to anode.

The material is removed from the cathode, creating excess vacancies and the formation of a "tensile" stress field.

These vacancies migrate together and form voids. The electron wind piles up the atoms at the cathode.

This pile-up causes compressive stress to build up between the wire and the surrounding passivation.

For high currents, cracks form and the Al or Cu squeeze out of the wire.

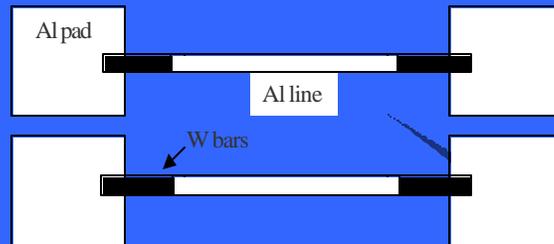
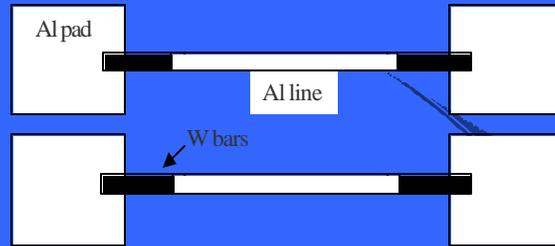
Passivated Al/0.25 at. % Cu

10 μ m wide, 0.5 μ m thick, 200 μ m long.

100 \AA Ti/ 600 \AA TiN shunt layer.

Sputter dep./RIE/ 400 $^{\circ}$ C anneal.

W bars @ ends block diffusion to pads.

1.5 mm thick passivation (SiO₂)

100,000 Amps/cm², 302 °C.

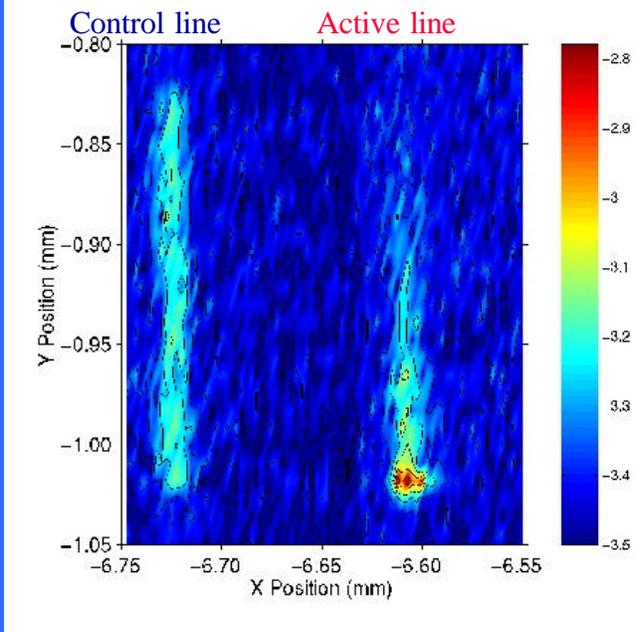
Cu-K α map

Cu distribution in the control line is ~ uniform.

Almost all Cu has migrated to the anode in the stressed line.

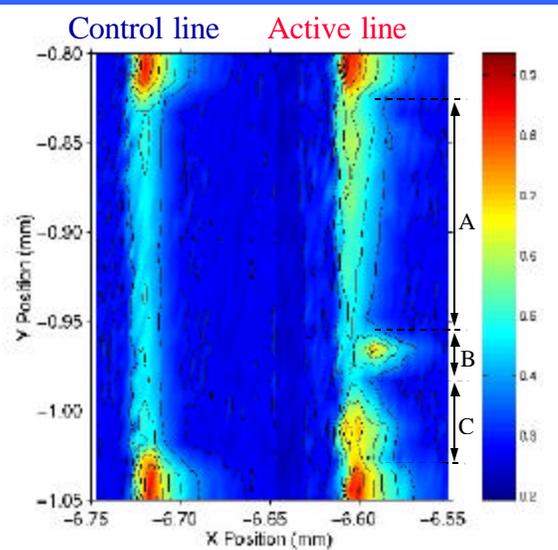
Si 004 topograph

Stress distribution in the control line is ~ uniform.

We observe intensity gradients in the stressed line indicating the formation of stress gradients..

There is an unexpected high stress region in region “B”.

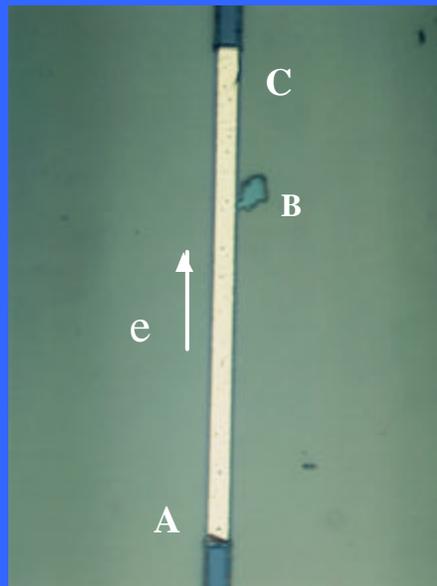
Optical microscopy indicated:

An extrusion @ B,

A depletion region at the cathode (A)

A crack at the anode (C)

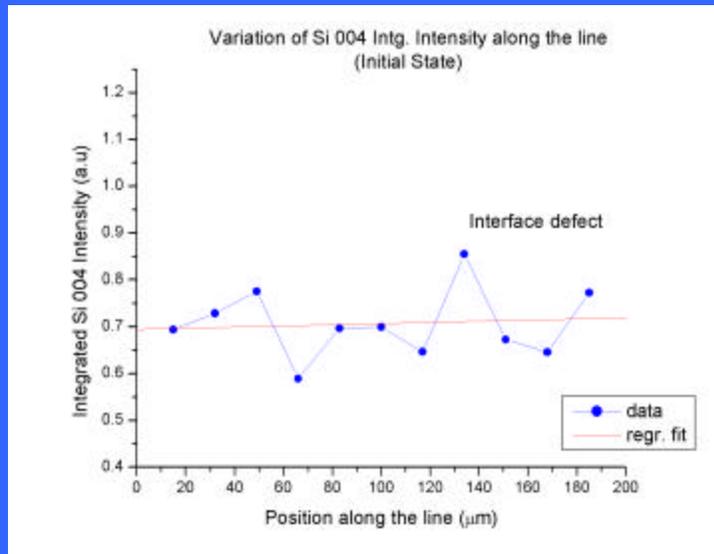
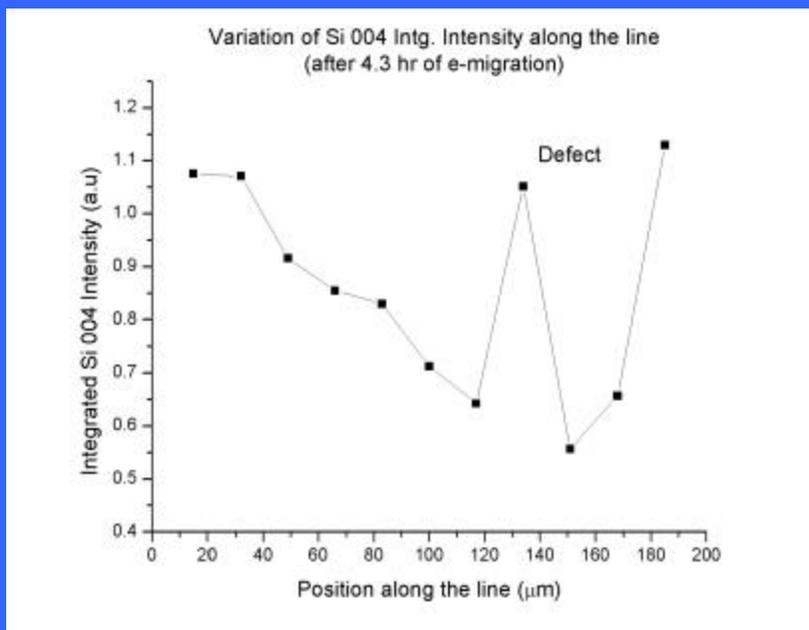
Regions B+C

The extrusion formed @ a local defect.

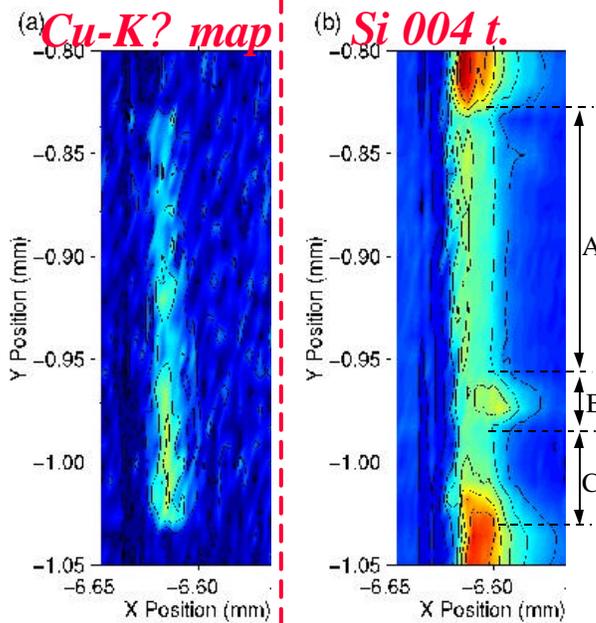
If we turn off the current but leave the heat on, relaxation occurs.

- Cu flows back
- Stress becomes more uniform.

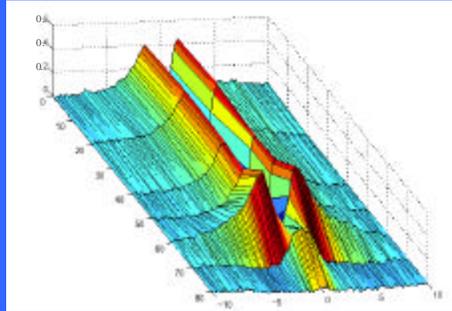
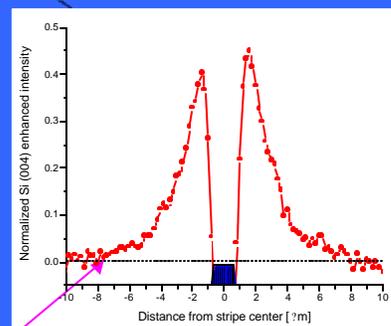
Experimental: 1.5 μm SiGe feature on Si (001)

Normalized Si diffracted intensity [I/I_0]

Distance from stripe center [μm]

- Distortion in Si substrate detected $\sim 7 \mu\text{m}$ away from stripe edge.
- The smaller the beam size, the better the resolution.

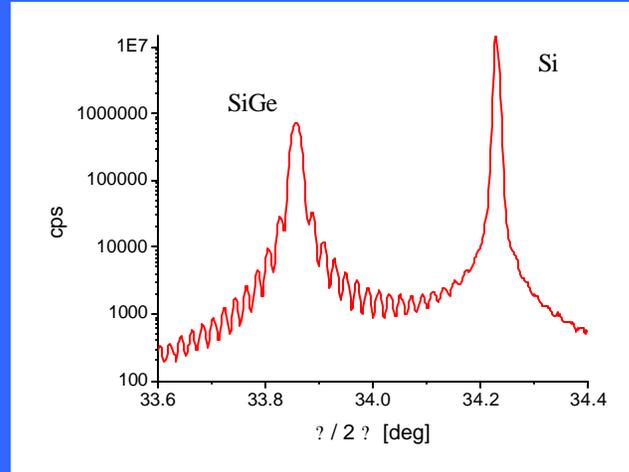
Blanket SiGe prior to etching

2θ scans at feature centers

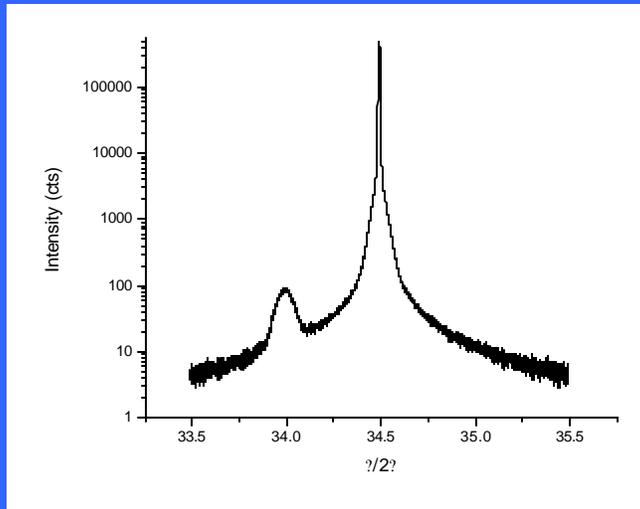
Bulk average of processed SiGe features

2θ scans at feature centers

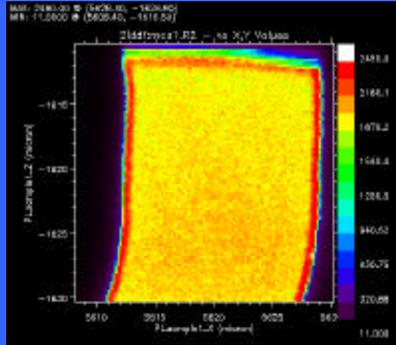
Ge K α fluorescence

16 x 2048 μ m feature

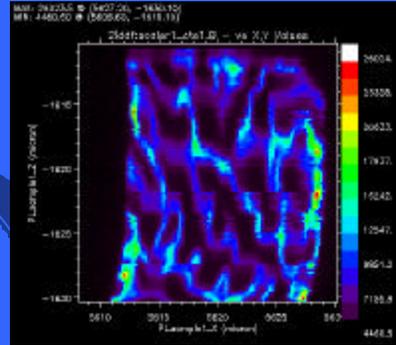
SiGe (004) diffracted intensity

The drift is due to temperature change.
